Date	26.03.20		2x Fan RP6	Position	=	Sheet 60
Draw.	MaWi				+	
Check						
Status	rev.	Date	Nom	Norm	Project pages	Sheet 60
					Total 82	von 82Bl.
					actual 60

Date	26.03.20		4x Fan RP6	Position	=	Sheet 82
Draw.	MaWi				+	
Check						
Status	rev.	Date	Nom	Norm	Project pages	Sheet 82
					Total 82	von 82Bl.
					actual 82

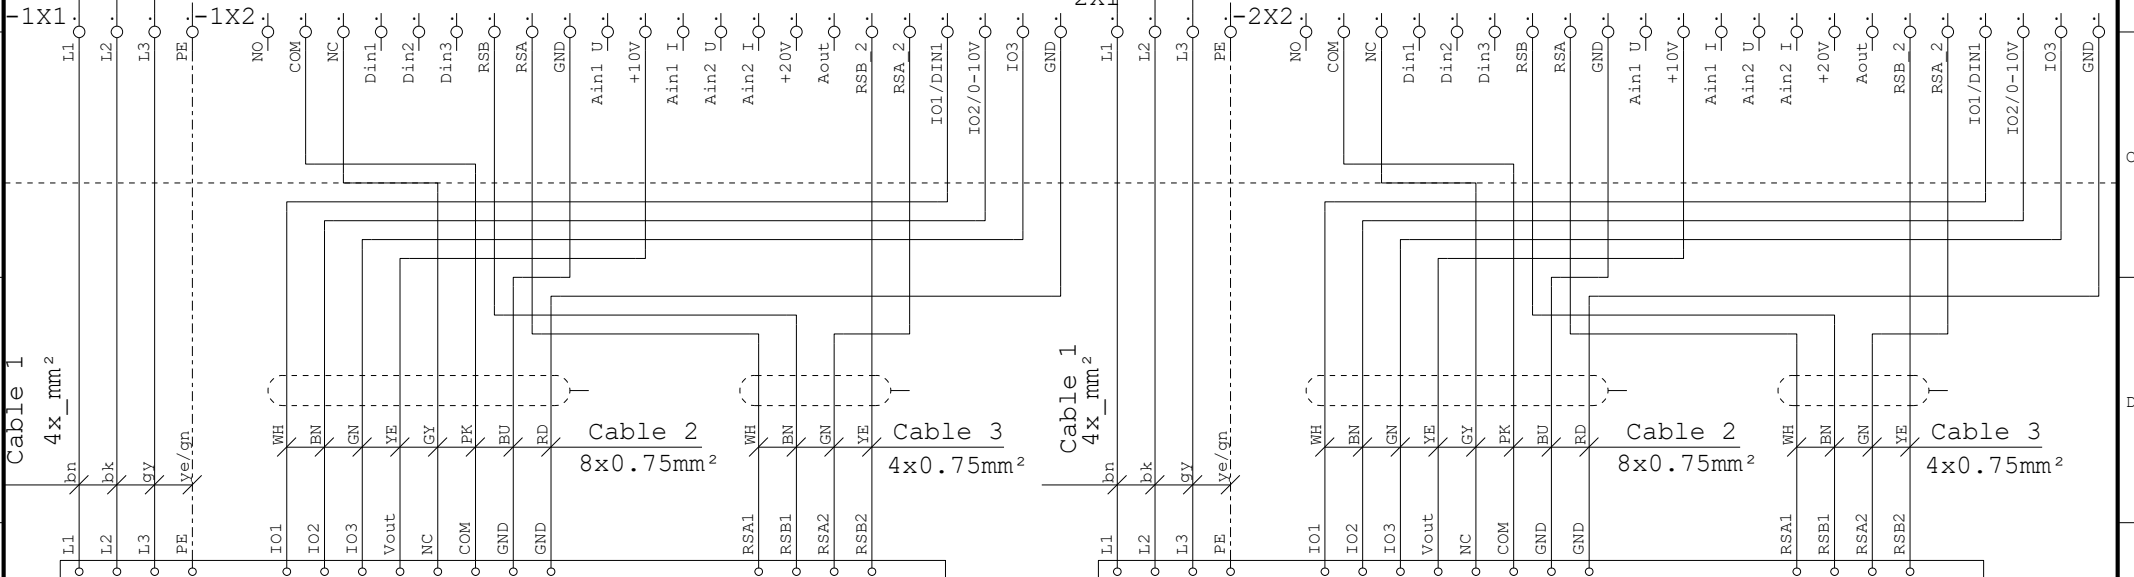
Attention!!
If a repair switch is selected,
the connection is made directly to the repair switch
without connection to the terminals

Junction Box

Motor 1

Motor 2

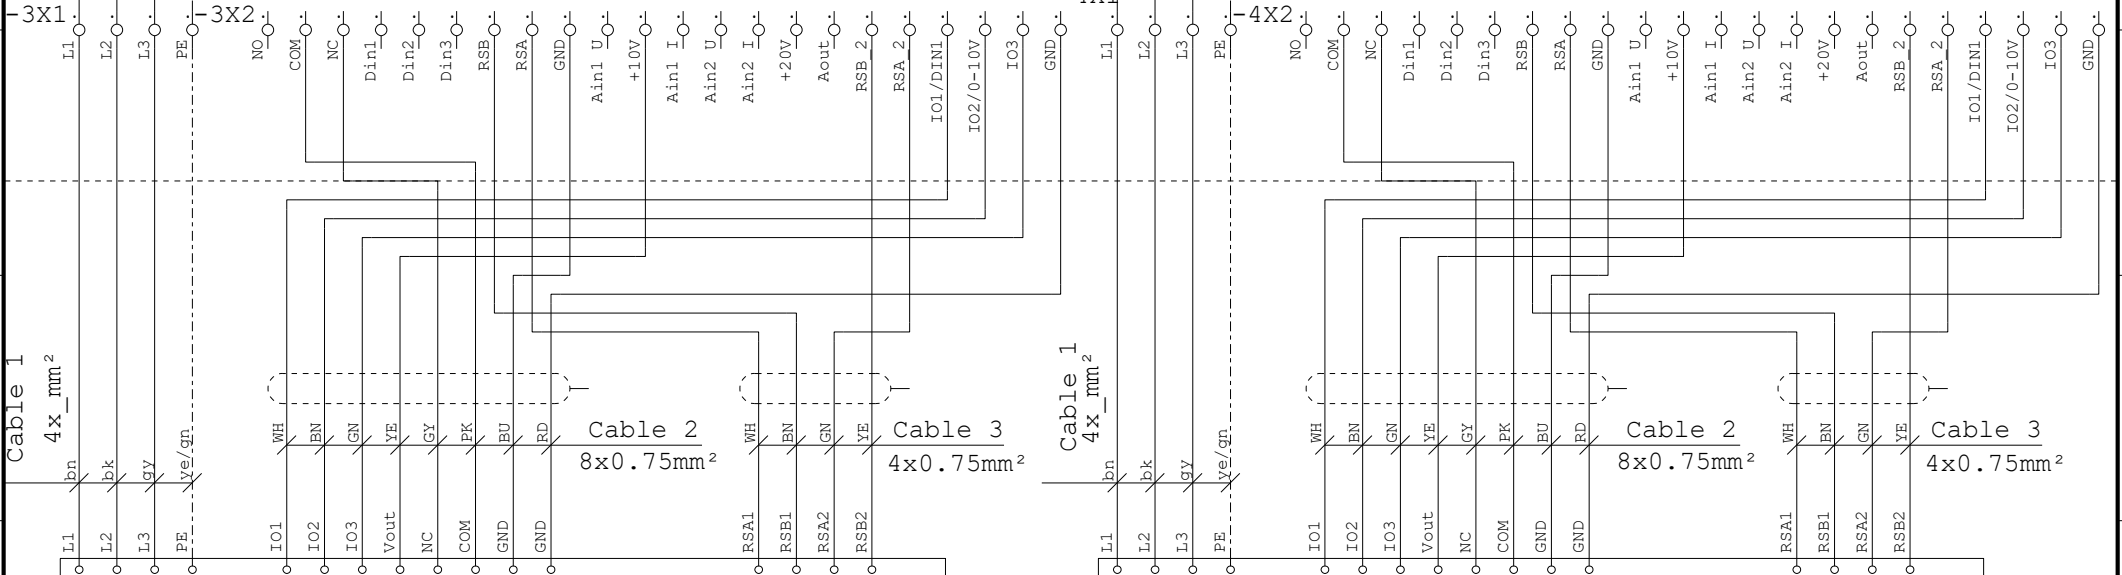
Attention!!
If a repair switch is selected,
the connection is made directly to the repair switch
without connection to the terminals

Junction Box
