Date	26.03.20			Position		=
					Draw.	MaWi			8x Fan RP6		+
					Check				Project pages		Sheet 89
Status	rev.	Date	Nom	Norm					Total	89	von 89Bl.
									actual	89

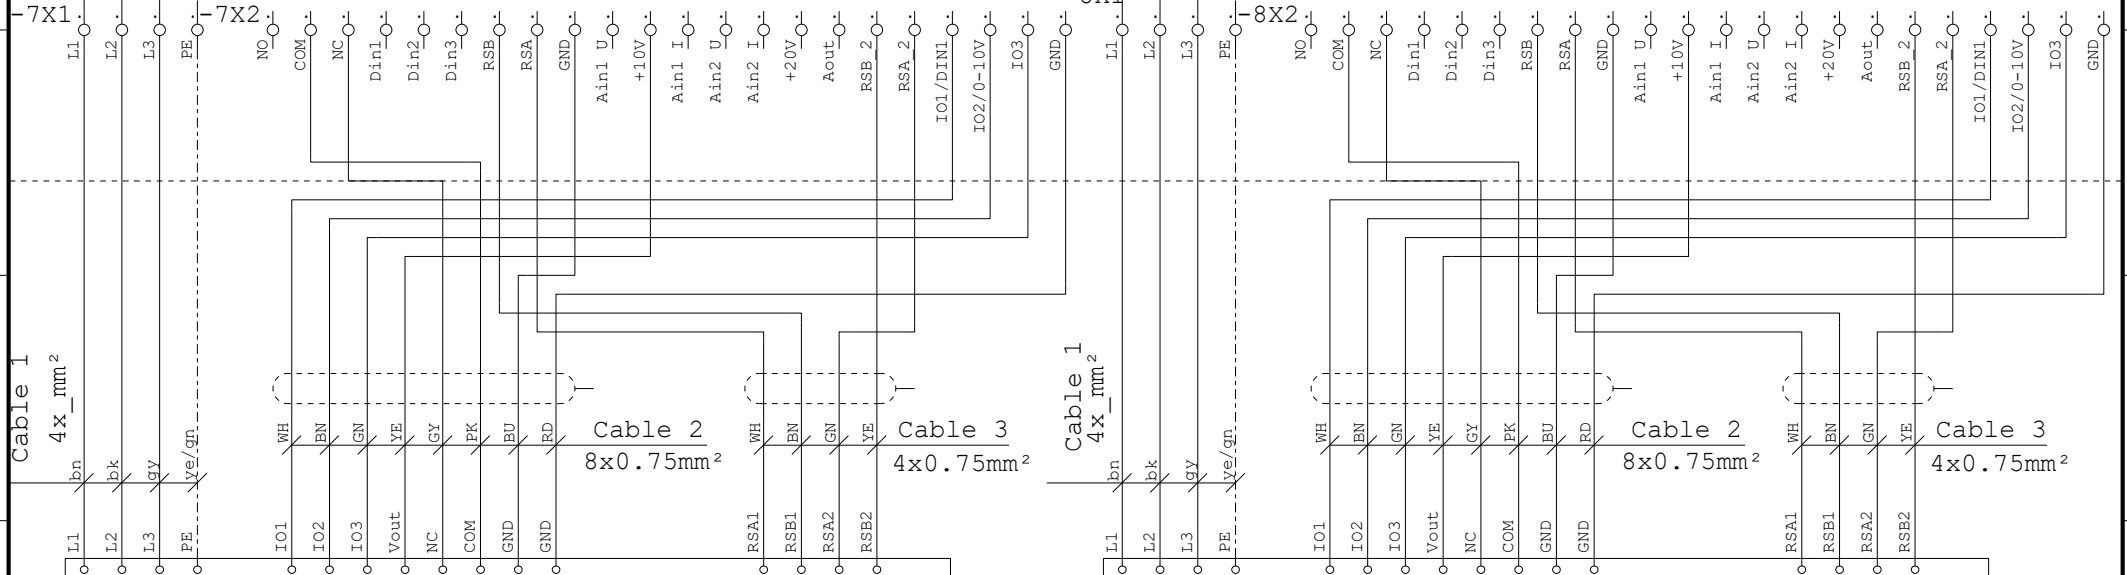
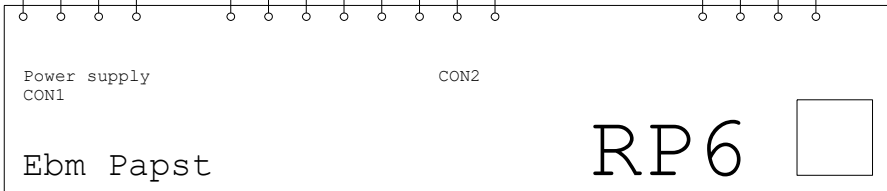
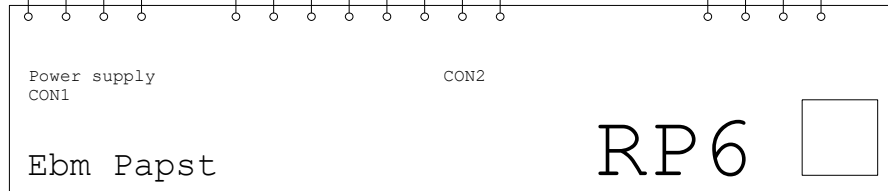
### Junction Box

Attention!!  
If a repair switch is selected,  
the connection is made directly to the repair switch  
without connection to the terminals

Motor 7

Motor 8

For more information - see datasheet of EBM Papst
